OPERATING EXPERIENCE WEEKLY SUMMARY

Office of Nuclear and Facility Safety

January 16 - January 22, 1998

Summary 98-03

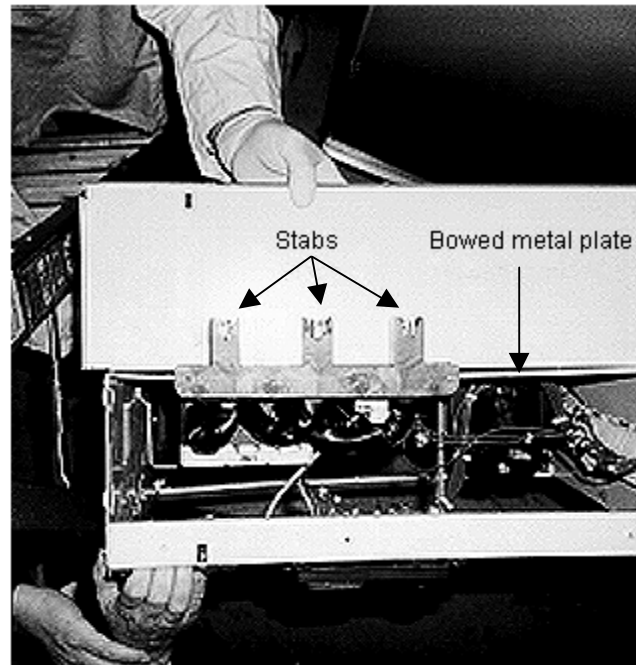
Figure 2-1. Damaged Circuit Breaker Bucket

The fan had been shut down since October 1997, because of a turning vane problem. Operators started the exhaust fan in slow speed to run for an hour to warm up the bearings. After the warm-up period, they shifted the fan to fast speed, and the motor control center failed when arcing occurred between a stab (friction connector) and its bus bar.

In July 1997, a loss-of-phase condition caused internal protection circuits to activate in the same size 5 Westinghouse motor control center that controlled the exhaust fan. After maintenance personnel replaced the protection circuits, operators restarted the fan, but the motor control center failed again because of arcing between the bus bar and a friction stab. Investigators determined that the arcing occurred because the electrical conductor stabs did not make complete contact with the bus bars in the motor control center. Figure 2-1 shows the circuit breaker bucket with damaged stabs. It also shows the amount of bow (flex) in the metal plate that holds the stabs. Stiffeners were added to reinforce this plate.

After the July failure, facility operations personnel disassembled the unit to determine the source of the trouble. They discovered that the manufacturer had installed the mounting brackets for the bus bars backwards. Operations personnel removed the complete back plane from an identical spare motor control center. They planned to install it in the failed unit to return the motor control center to service. However, upon disassembly of the spare motor control center, they discovered that the brackets in that unit were also installed backwards. Operations personnel installed the spare plane in the motor control center for the exhaust fan and correctly installed the bus-bar mounting brackets.

Facility operations personnel contacted the manufacturer for assistance with troubleshooting and repair of the motor control center. A Westinghouse representative inspected the unit and found that workers at the factory improperly installed the mounting brackets. He also verified that facility operations personnel correctly installed the brackets from the spare. The Westinghouse representative also added stiffeners to the back plane. After operations personnel rebuilt the exhaust fan motor control center, they successfully tested it in accordance with the National Electrical Testing Association procedures and a test inspection plan. Tests included infrared thermograph readings, torque measurements, and megger readings.

Electrical maintenance personnel at DOE facilities that have this type of motor control center should check for (1) flexing of the back plane, (2) proper alignment and engagement of the circuit breaker buckets, and (3) deterioration of the stabs. Technical information can be obtained by contacting Merle Koepke (505) 665-2098 or Mike Kuzmack (505) 665-3281.

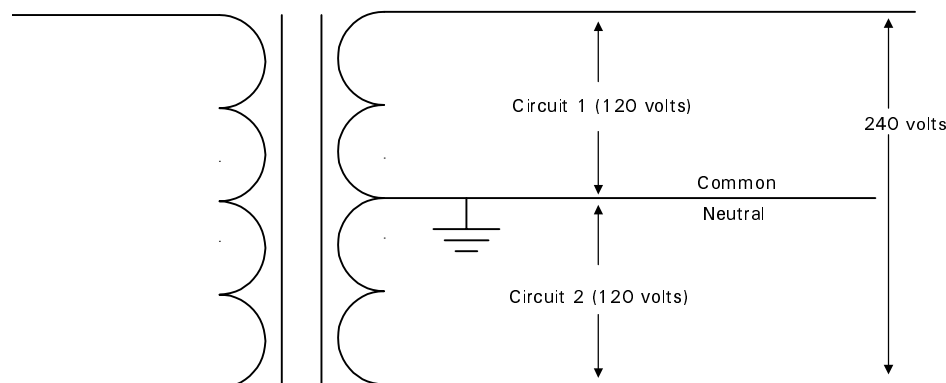
Figure 2-1. Typical Edison Circuit Wiring¹

Investigators determined that the two circuits shared a common neutral line, a practice commonly referred to as an "Edison circuit." According to the occurrence report, this configuration is approved by the National Electrical Code, and is widely used, especially in non-industrial service such as 120-volt lighting and receptacles. Figure 2-1 shows the wiring of a typical Edison circuit. The DOE-Idaho Operation Office *Architectural Engineering Standards*, dated November 1994, no longer permit this practice for new construction at the Laboratory.

- Install additional neutral wiring to eliminate the Edison circuit.
- Install clips on the affected circuit breakers that will open when either "hot" leg of the Edison circuit is opened.
- Post warning signs on the panels indicating that Edison circuits are installed in the associated electrical systems.
